Matilija Dam Ecosystem Restoration Project Giant Reed Removal Element

Post-Treatment Vegetation Monitoring Program

31 December 2009

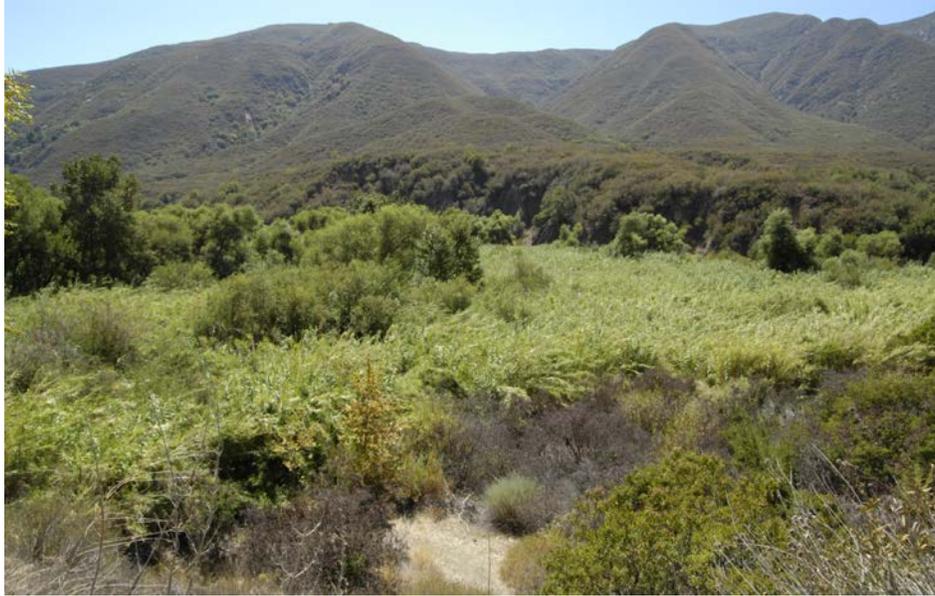
Figure 3a. Heavy infestation of woodland by giant reed in Reach 7a. Remnant native riparian trees visible here include *Salix lasiolepis*, *Platanus racemosa*, and *Populus fremontii* (photo taken 4 September 2007).

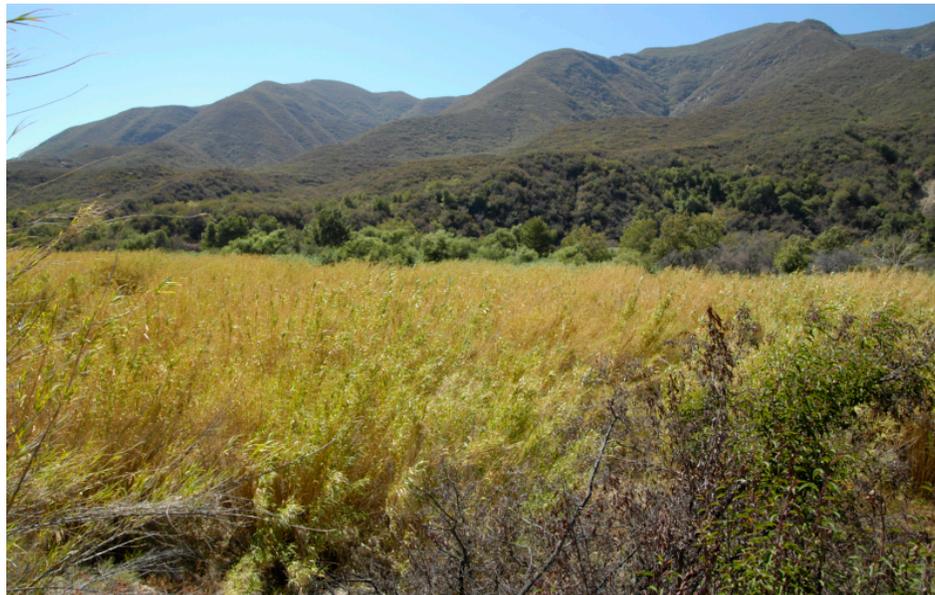
Figure 3b. Heavy infestation of floodplain scrub by giant reed in Reach 7a,b (photo taken 4 September 2007).

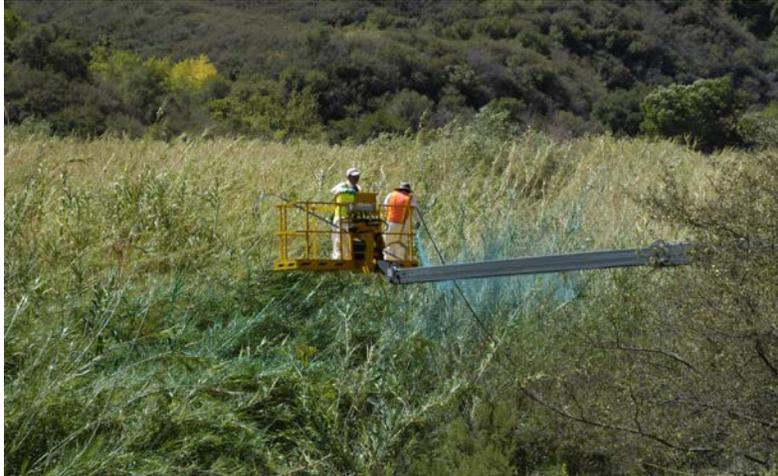
Figure 4a. Foliar application of herbicide in monotypic stands of giant reed (photo taken 10 September 2007).

Initial Treatment of Non-Native Vegetation. Initial treatment of target invasives in the project area began on 10 September 2007 and was completed on 12 June 2008 in Reaches 5a,b, and Reaches 6 through 9. Reach 5c (downstream end of Phase 1 project area – Figure 1), received initial treatment in October 2009. A glyphosate-based systemic herbicide was sprayed on target foliage, allowed to translocate to all portions of the plant for a minimum of 30 days, then followed by mechanical shredding and/or cut-daub methods, depending on the intensity of infestation (Figures 4a-f).

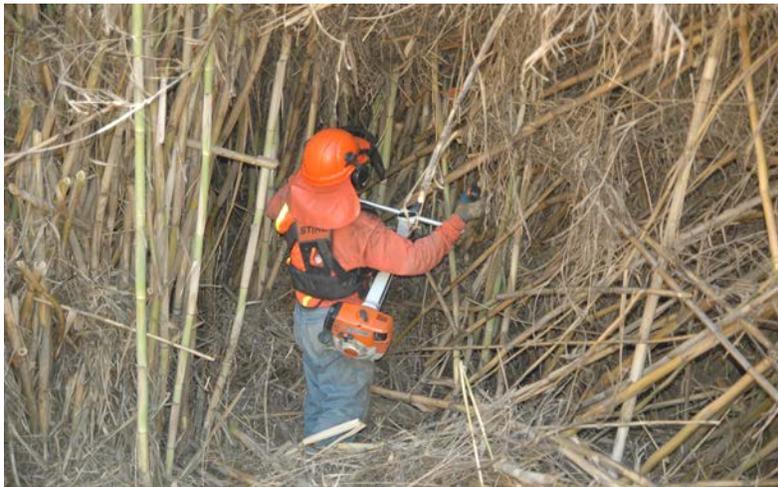
Figure 4b. Worker cutting giant reed with blade trimmer; cut stems were then daubed with herbicide (photo taken 27 September 2007).

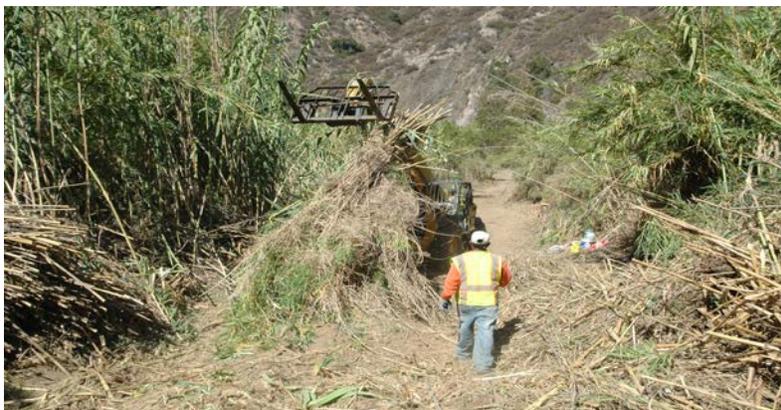
Figure 4c. Hauling giant reed cut by hand to central location for shredding. Note amount of ground litter (photo taken 27 September 2007).

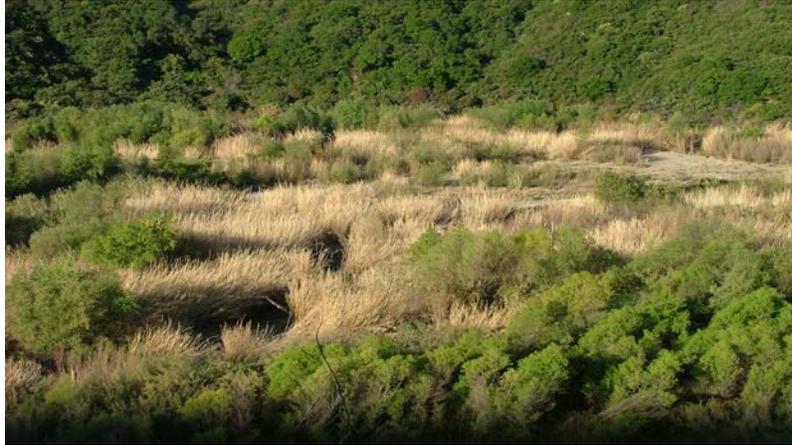
Figure 4d. Post-treatment aspect of floodplain woodland in area where giant reed was sprayed and left in place (photo taken 11 April 2008).

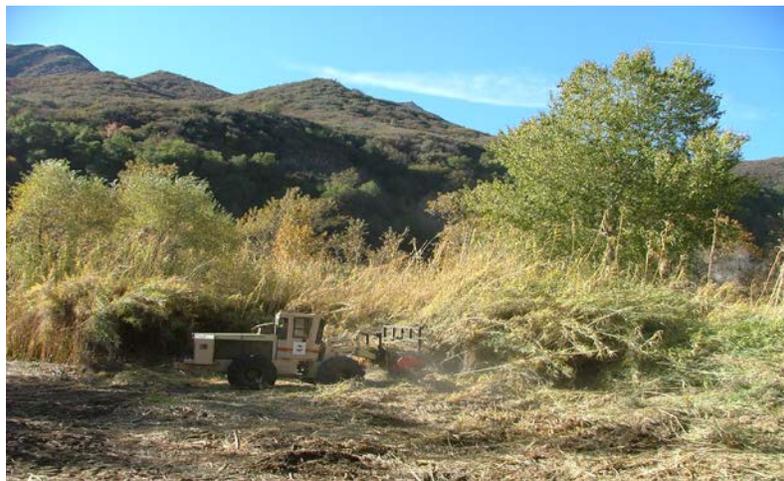
Figure 4e. *In situ* shredding of giant reed in woodland (photo taken 12 December 2007).

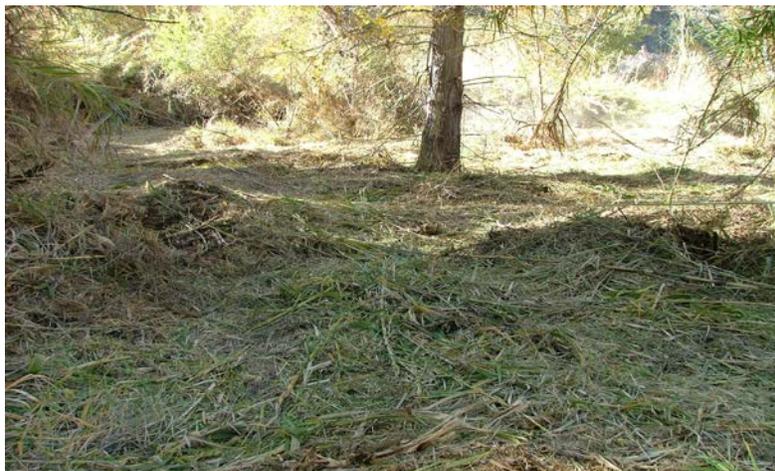
Figure 4f. Woodland substrate following shredding of giant reed with shredder shown in Figure 5e (photo taken 12 December 2007).
