Hydrology, Hydraulics, and Sediment Studies for the Meiners Oaks and Live Oak Levees - DRAFT Report

Matilija Dam Ecosystem Restoration Project, Ventura, CA

**U.S. Department of the Interior
Bureau of Reclamation
Technical Service Center
Denver, Colorado**

July 2007

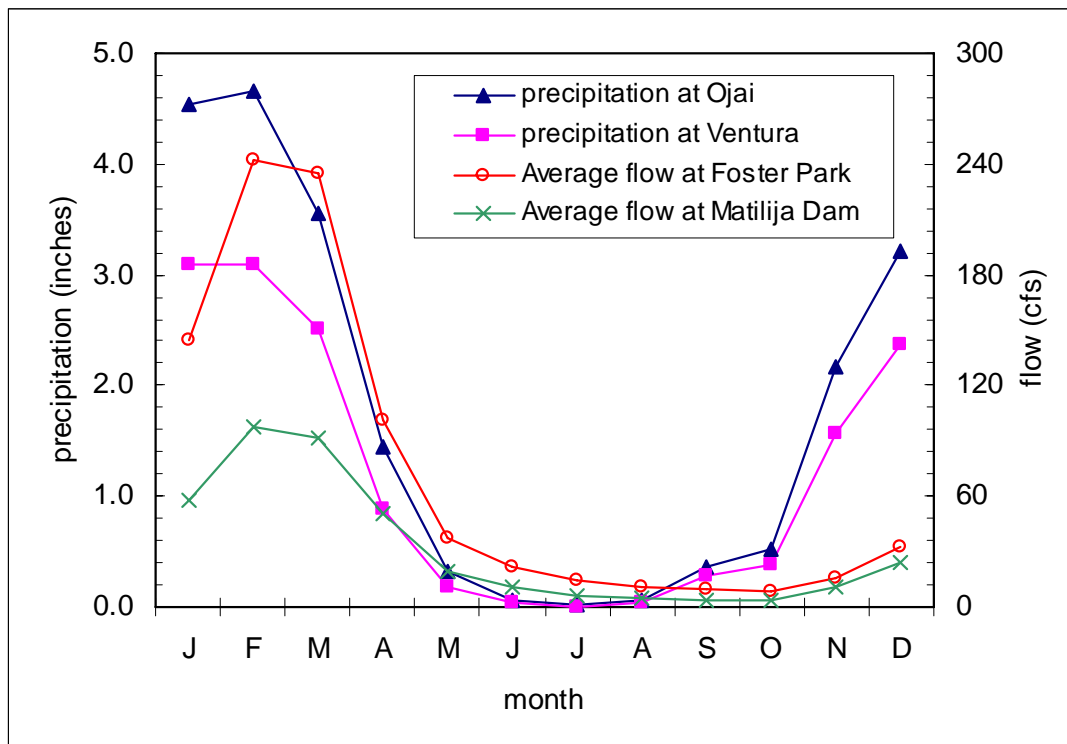
Figure 4. Seasonal variation of average rainfall and flow in Ventura River Watershed.

There is extreme seasonal variation in the rainfall and over 90 % of the rainfall occurs during the six months between November and April (Figure 4). The source of the rainfall data is the National Climatic Data Center (NCDC, <http://lwf.ncdc.noaa.gov/oa/ncdc.html>) rain gages in the cities of Ventura and Ojai. The period of record was from as early as 1874 until as late as 1995. The flows in the river show the same trend, but lag in time. This lag is due to the storage capacity of the soil in the watershed.

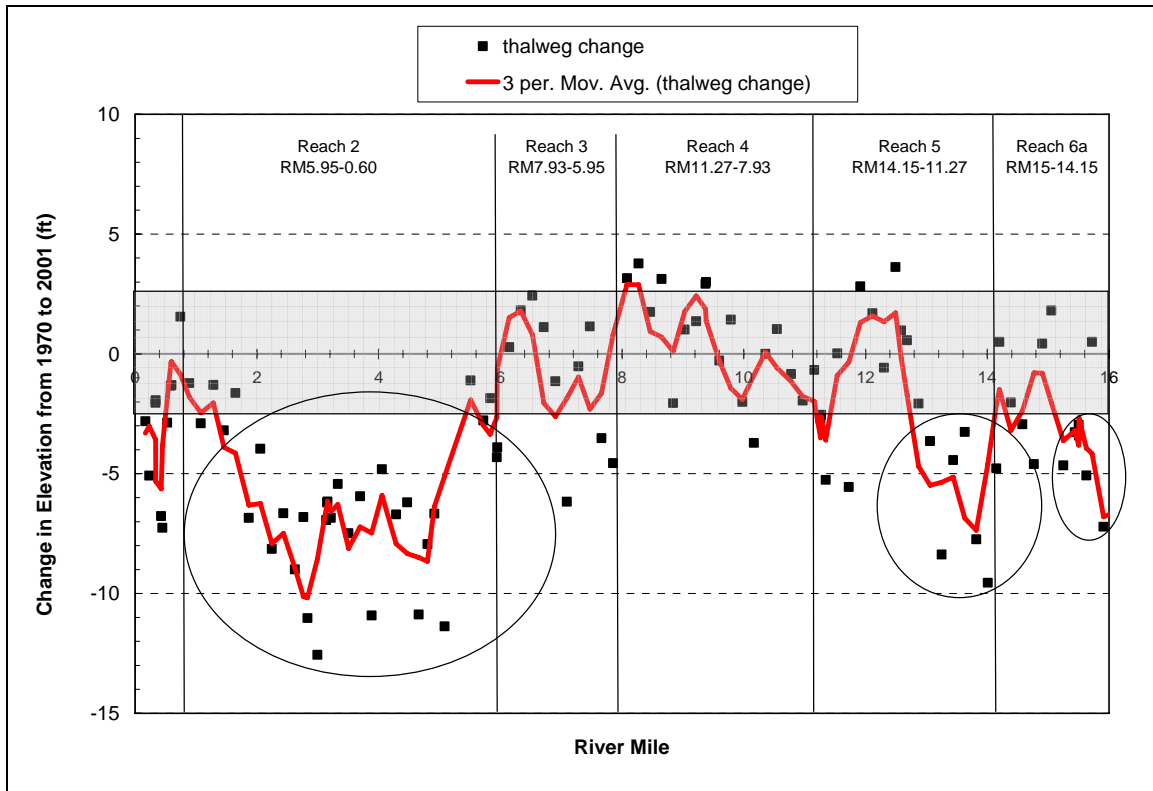
Figure 5. Comparison of change in thalweg elevation between 2001 and 1970. Negative changes indicate areas of degradation in the channel bed. Positive changes indicate areas that have aggraded. Areas within 2.5 feet of change are considered to be within the error range of the 1970 data.

Figure 5 shows the change to the thalweg elevations from 1970 to 2001. From RM 7 to 6 there has been less than 2.5 feet of change. A difference of less than 2.5 feet is not considered significant because the accuracy of the 1970 survey is estimated to be +/- 2 feet and it was not possible to exactly locate the 1970 cross sections.

The elevations in the Live Oak reach have remained relatively stable since 1970. There may be some slight erosion in the upper part of the levee reach from RM 10 to 9.5, and some slight deposition in the reach from 9.5 to the Santa Bridge. However, the changes in elevation between 1970 and 2001 survey are not considered large.

The riverbed elevations have significantly lowered in the Meiners Oaks Reach from RM 14.0 to 13.0. Immediately below Robles Dam there has been up to 10 feet of erosion. From RM 13.0 to RM 12.0 there has likely been some deposition.

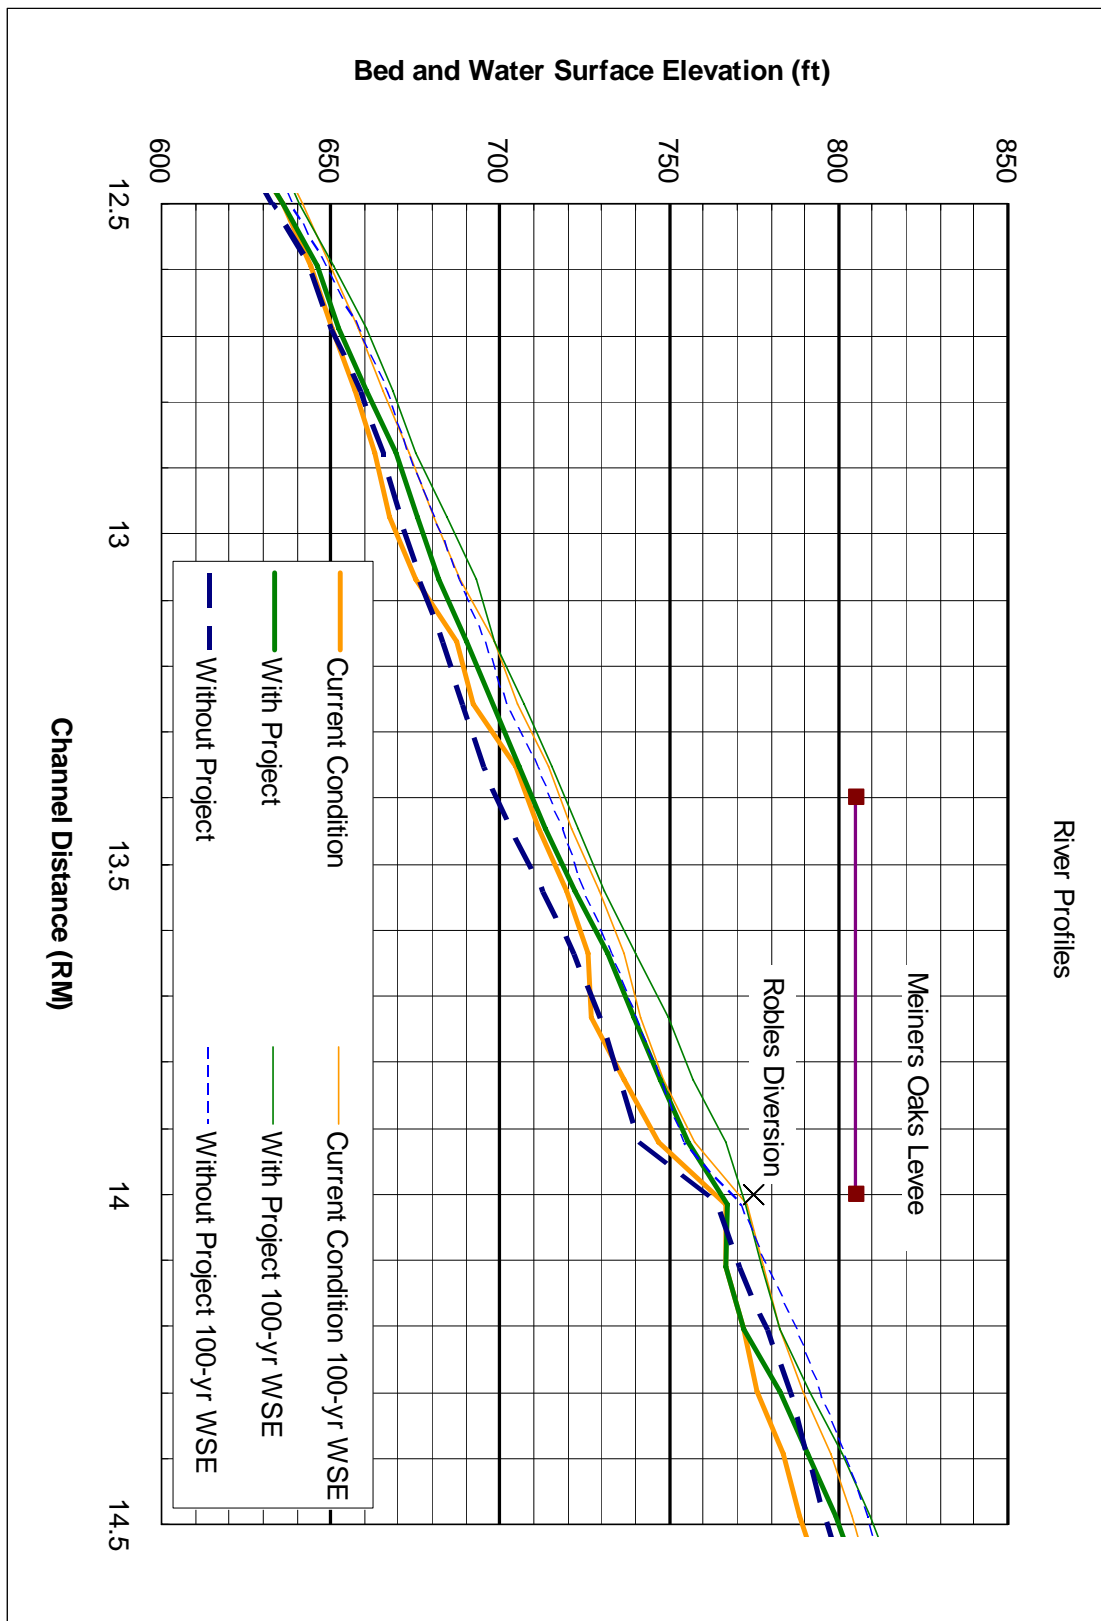
Figure 6. Bed and Flood Elevations near Meiners Oaks Levee.

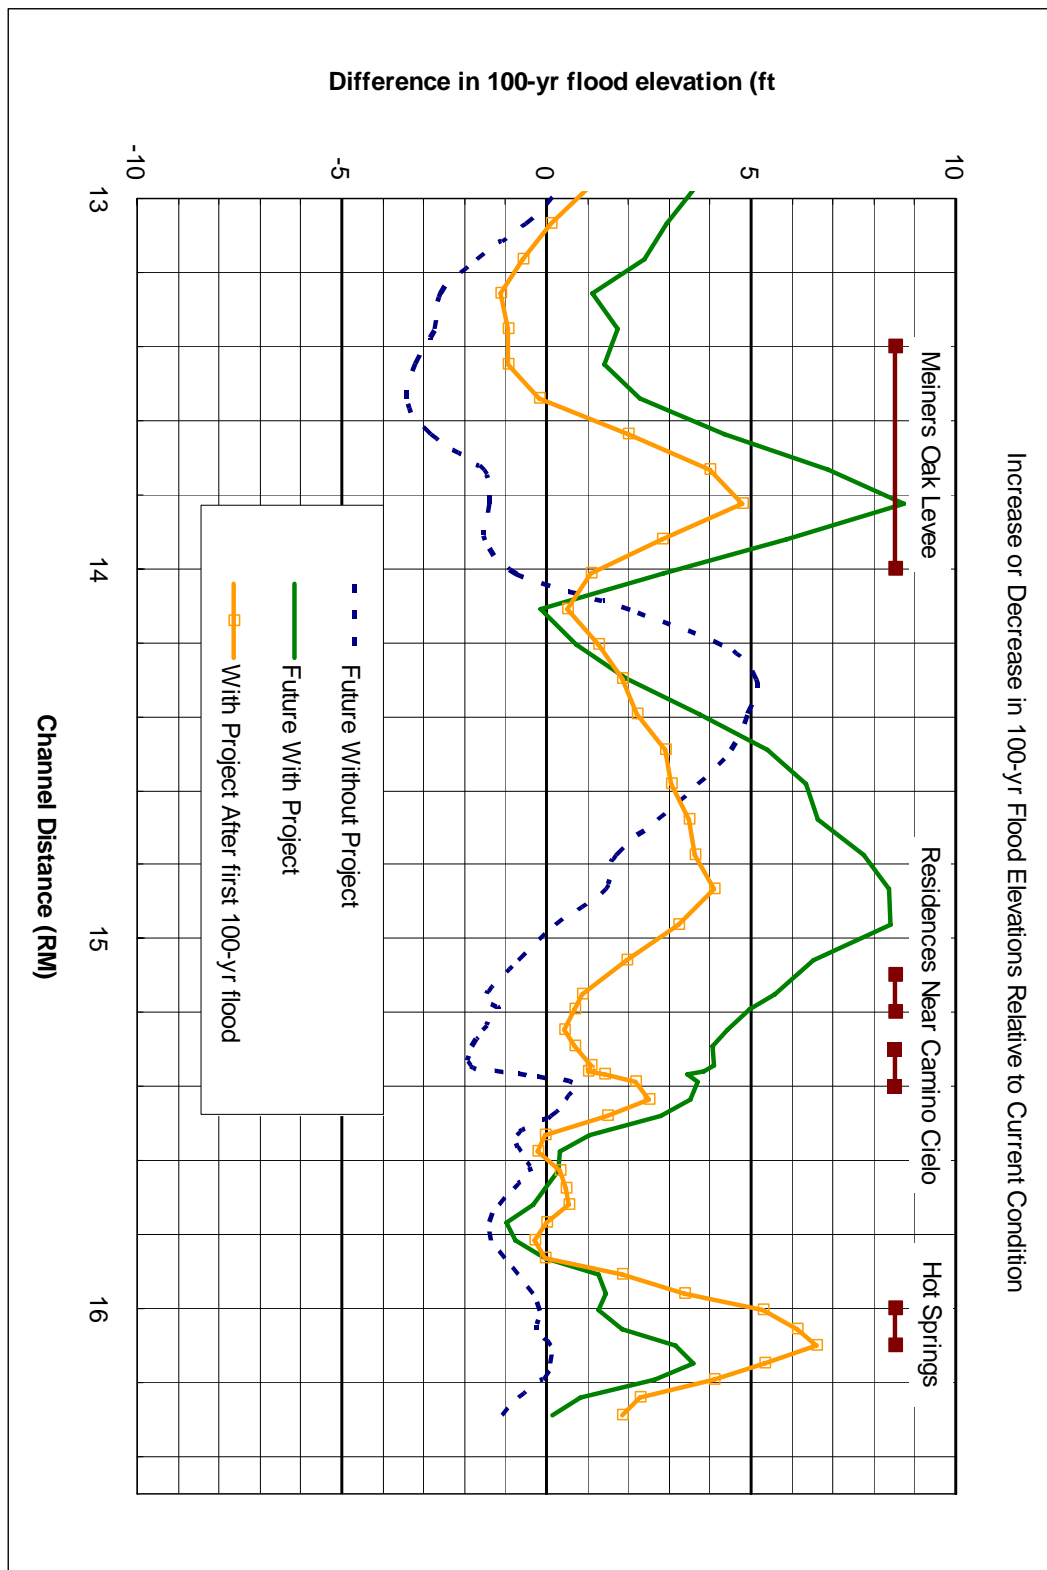
Figure 7. Change in Water Surface Elevations Relative to Current Condition near Meiners Oaks Levee.

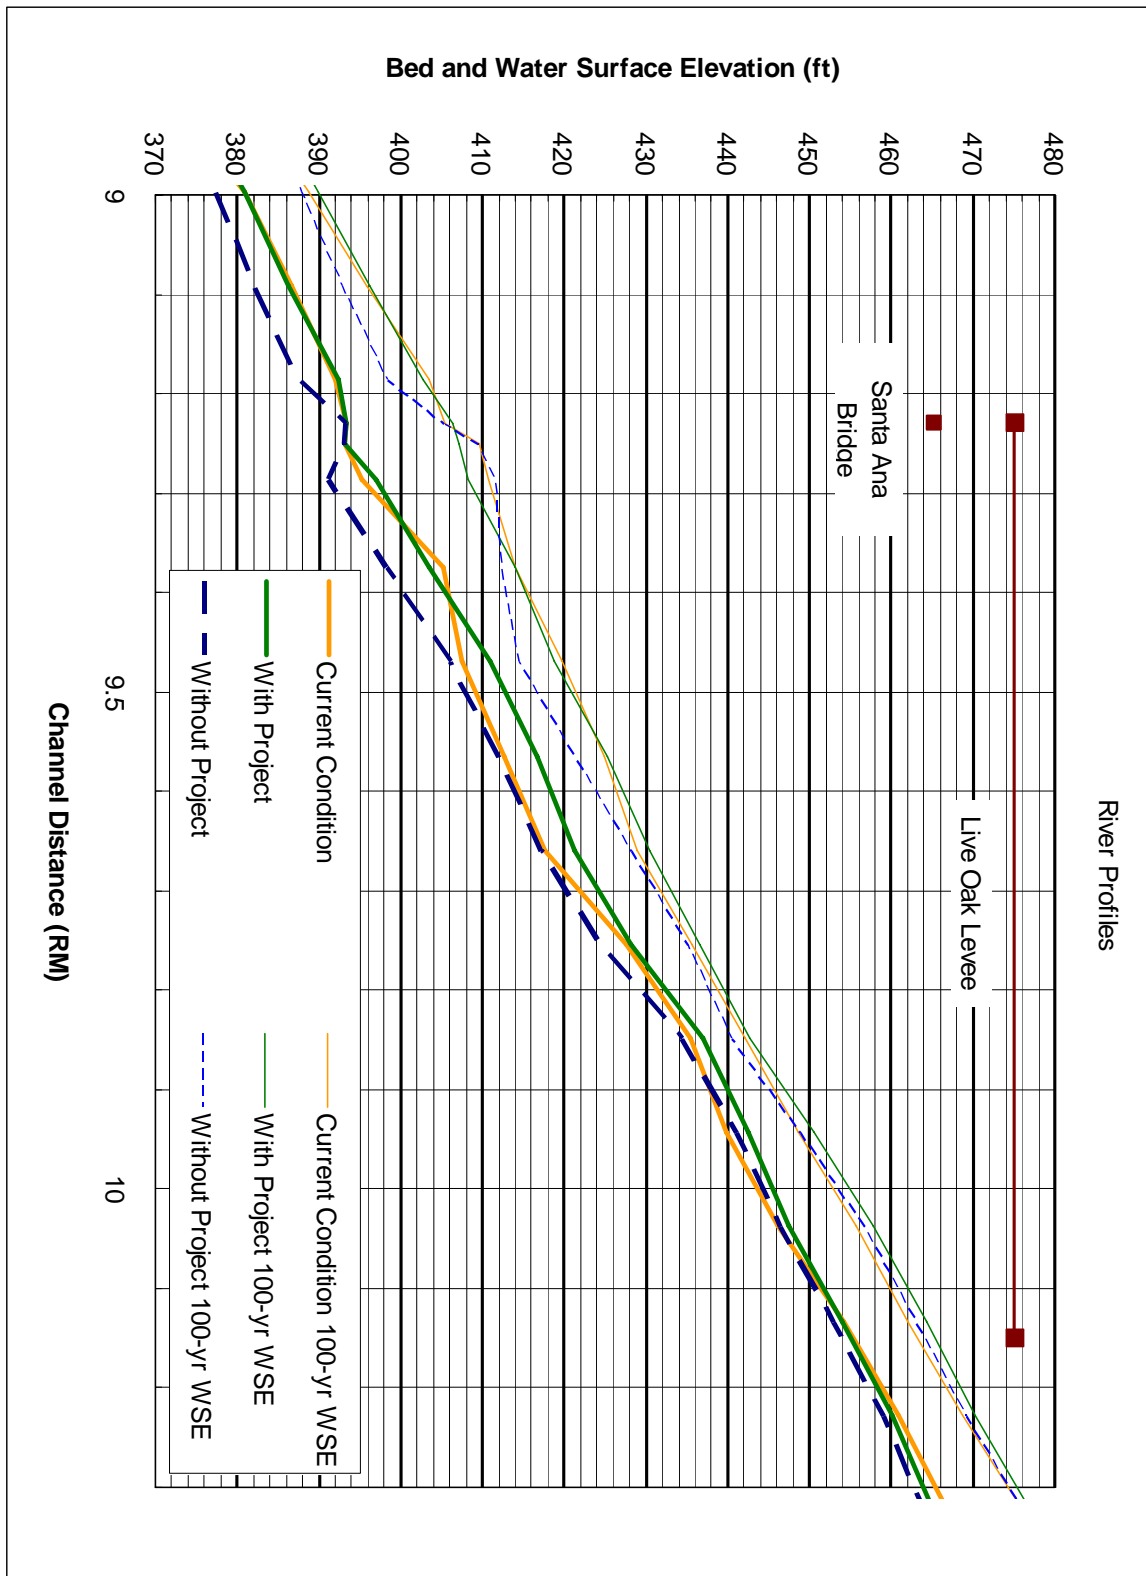
Figure 8. Bed and Flood Elevations near Live Oak Levee.

Live Oak Levee: The thalweg elevation (the elevation of the lowest point on the cross section) will increase throughout most of the Live Oak reach (Figure 8). Figure 9 shows the change to the 100-yr water surface elevations relative to current conditions. From RM 10.15 to 9.5, deposition will increase the 100-yr flood water surface elevations approximately 1 to 2 feet. Nearer the bridge, from RM 9.5 to Santa Ana Bridge, the flood water surface elevations will decrease 1 to 2 feet. The drop in water surface near the

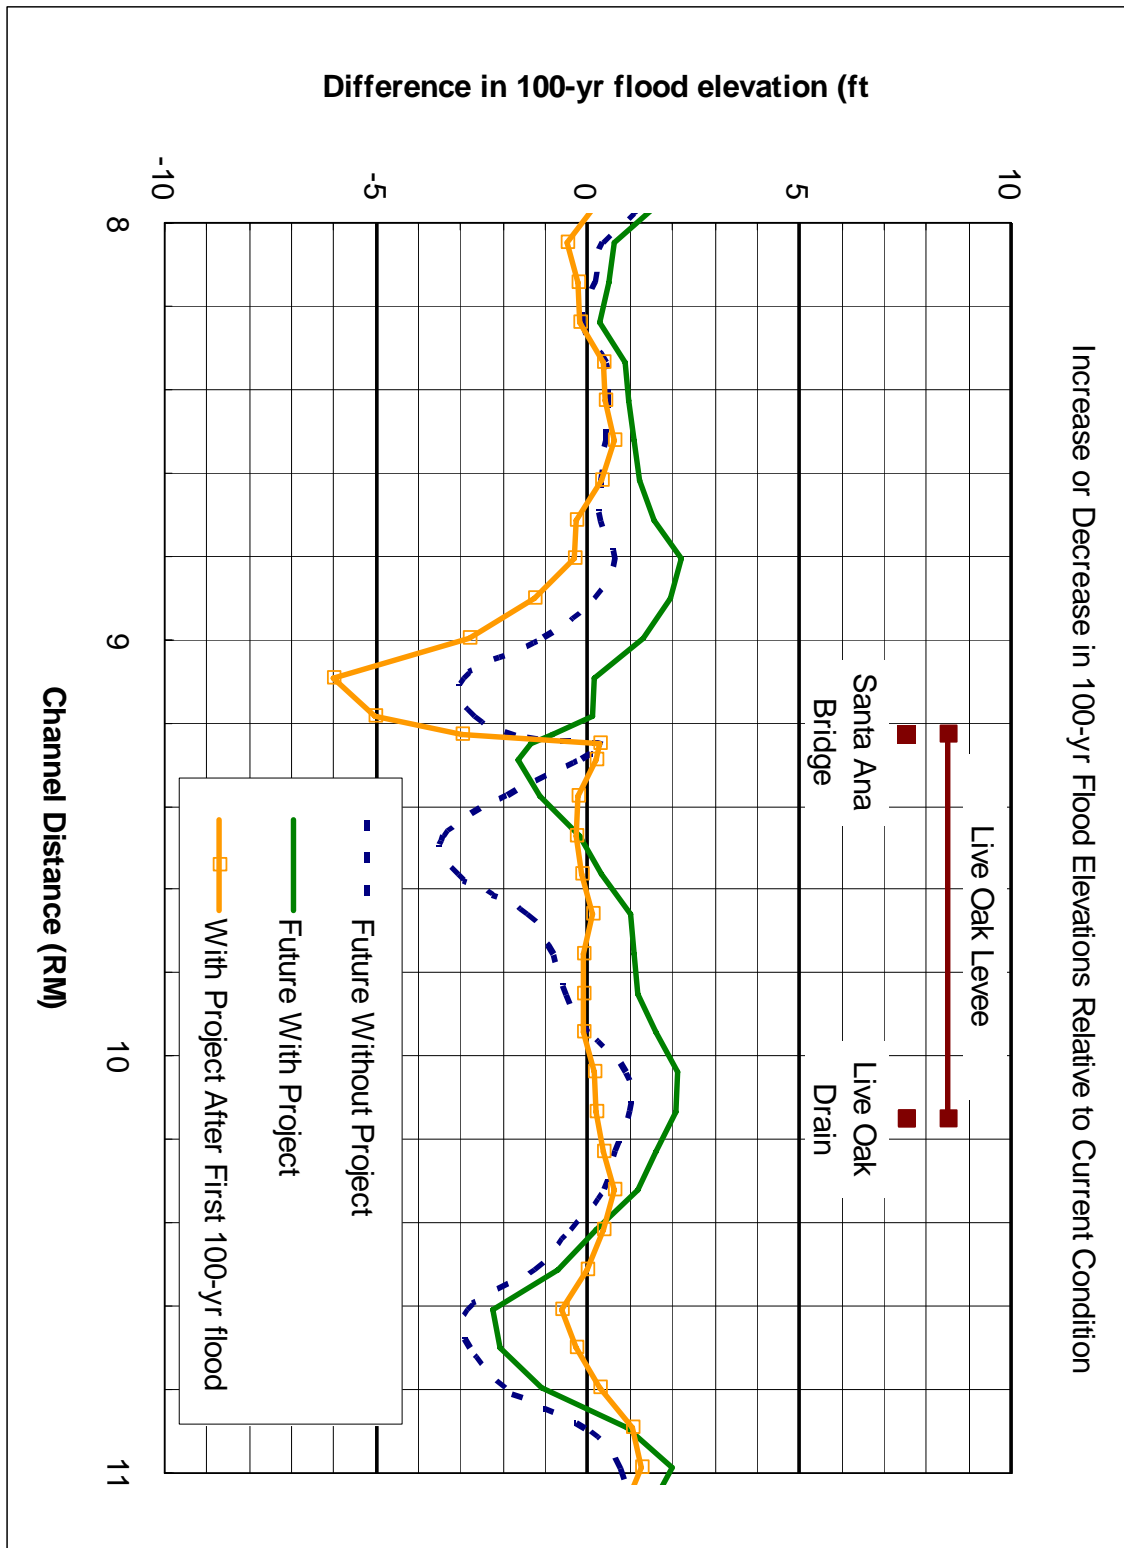
Figure 9. Change in Water Surface Elevations Relative to Current Condition Near Live Oak Levee.

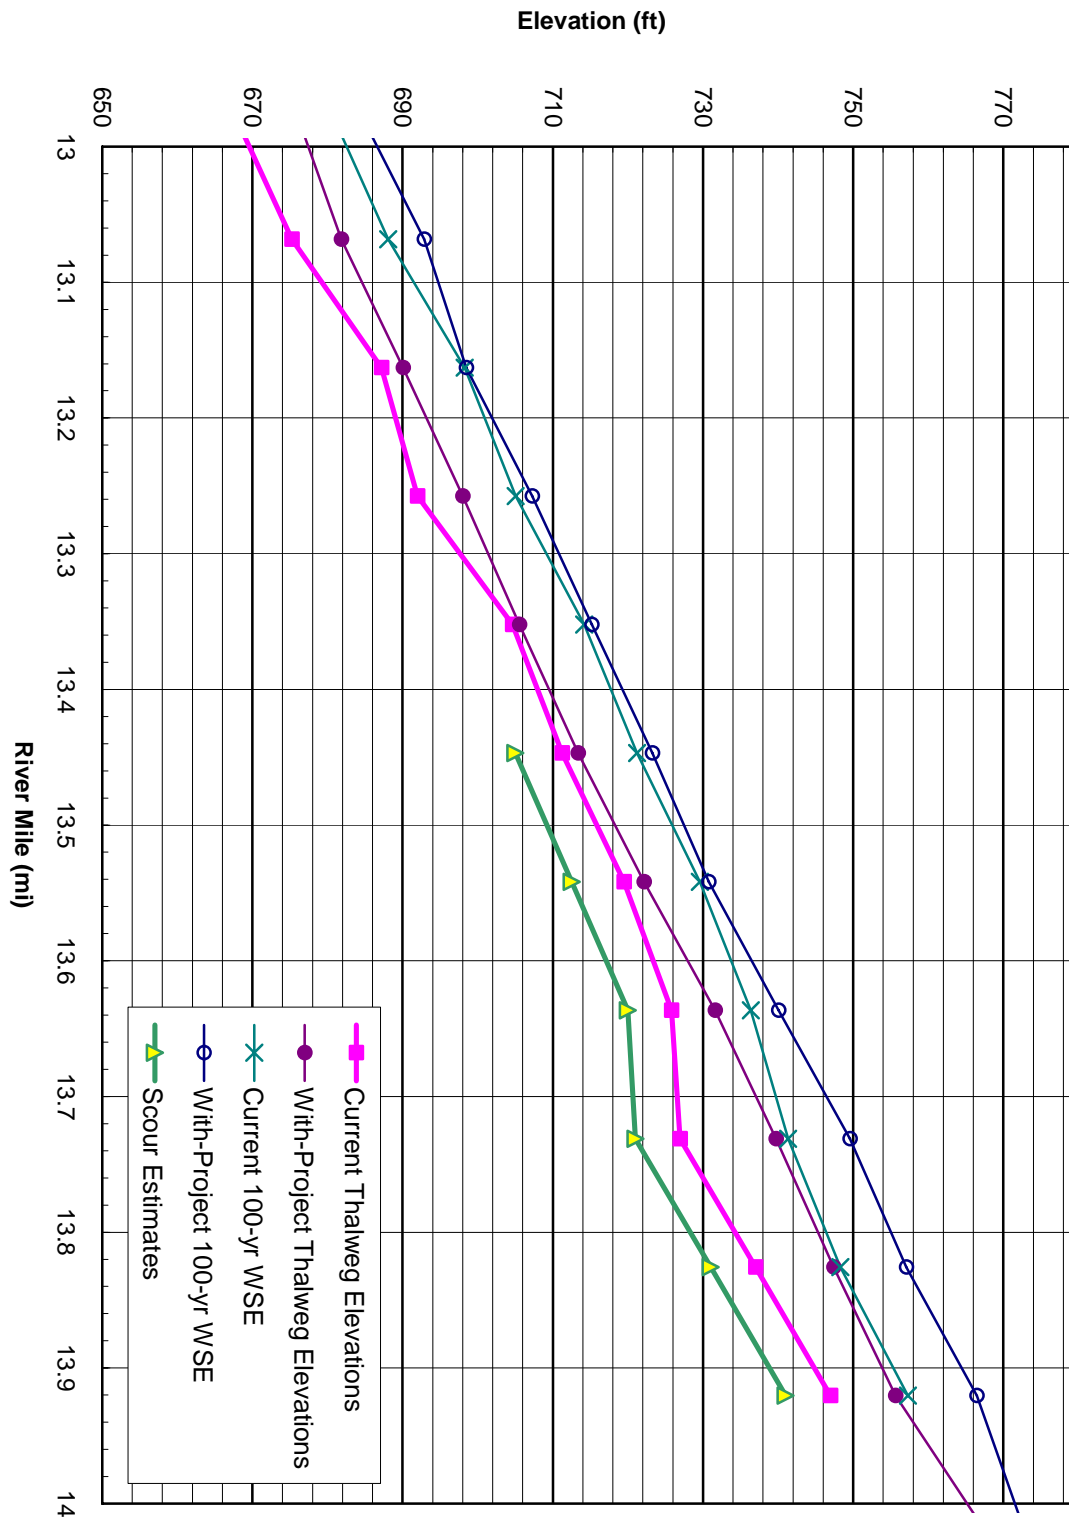
Figure 10. Scour Estimates for Riprap Design at Meiners Oaks Levee.

The results for each method are given in Table 11. The final design scour elevation at the well sites was computed from the average scour estimates from all the methods. A profile plot of the scour estimates giving the scour elevation for each well location is in Figure 10 and Figure 11, for the Meiners Oaks and Live Oak reach respectively.

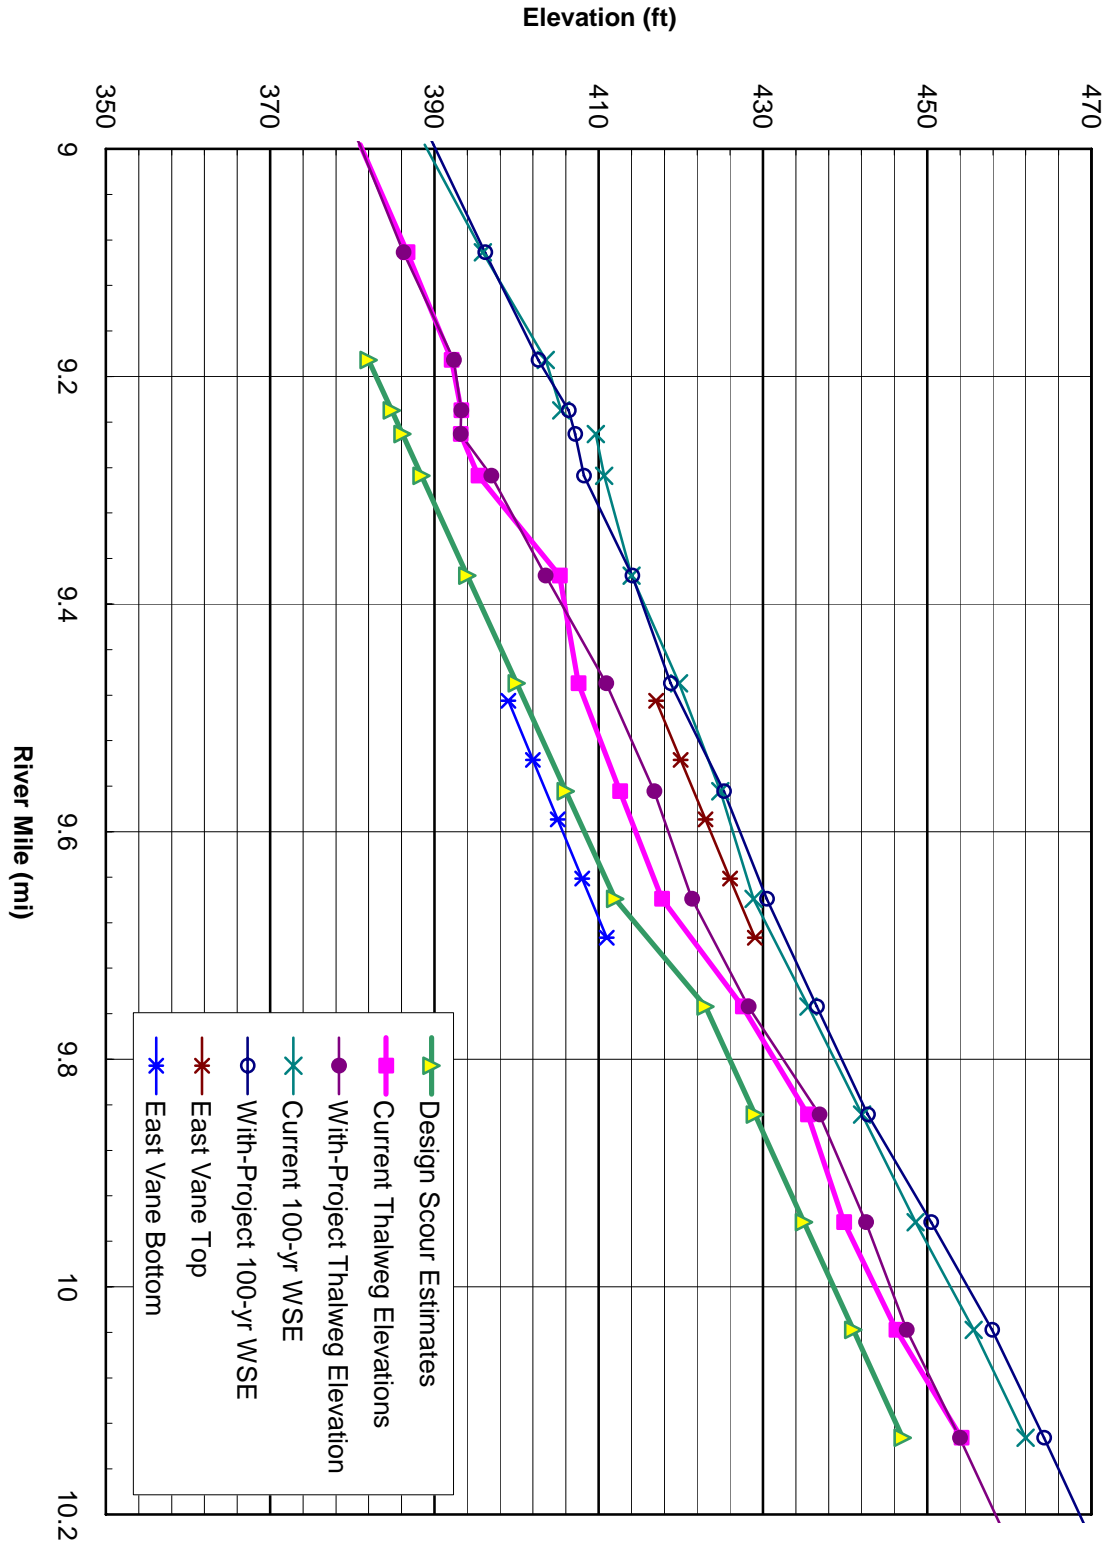
Figure 11. Scour Estimates for Riprap Design at Live Oak Levee.

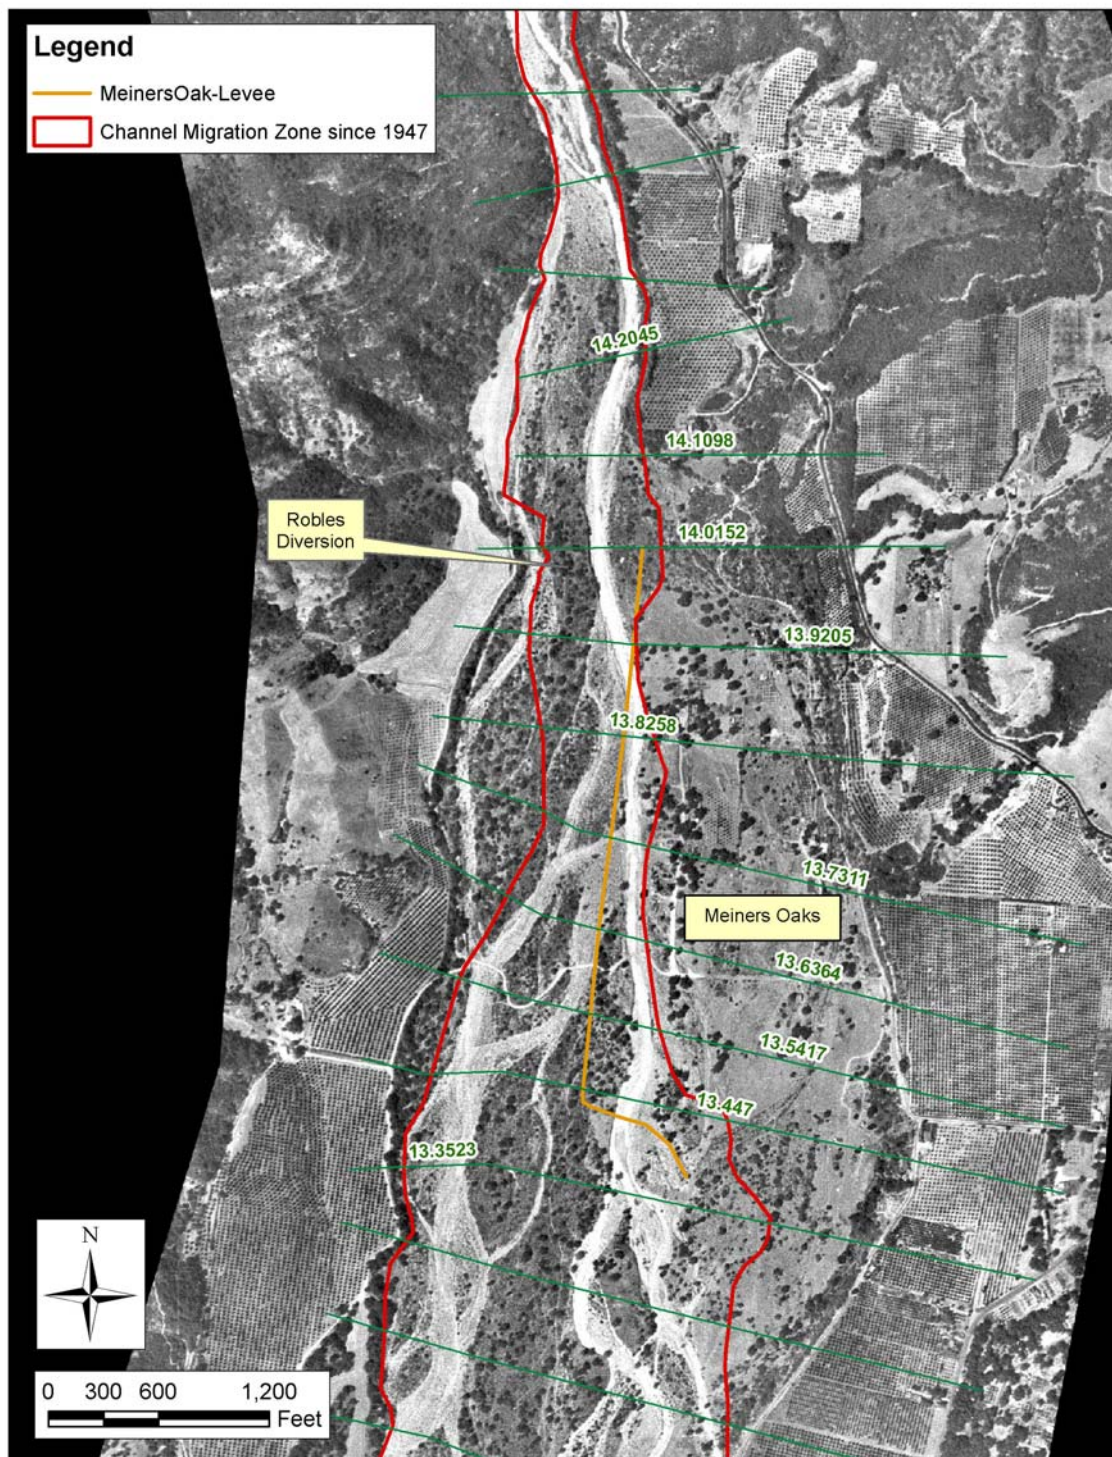
Figure 12. Meiners Oaks Aerial Dated 1947.

In 1947, the Ventura River had multiple channels through the Meiners Oaks Levee reach. The main channel was actually located to the east of the proposed levee location. Parts of the community being protected by the proposed levee are essentially in the active river bed of the Ventura River. The 1947 channel was relatively narrow, which was reflective of the dry conditions of the preceding years. Robles Diversion was constructed in 1958, so it does not appear in this photo

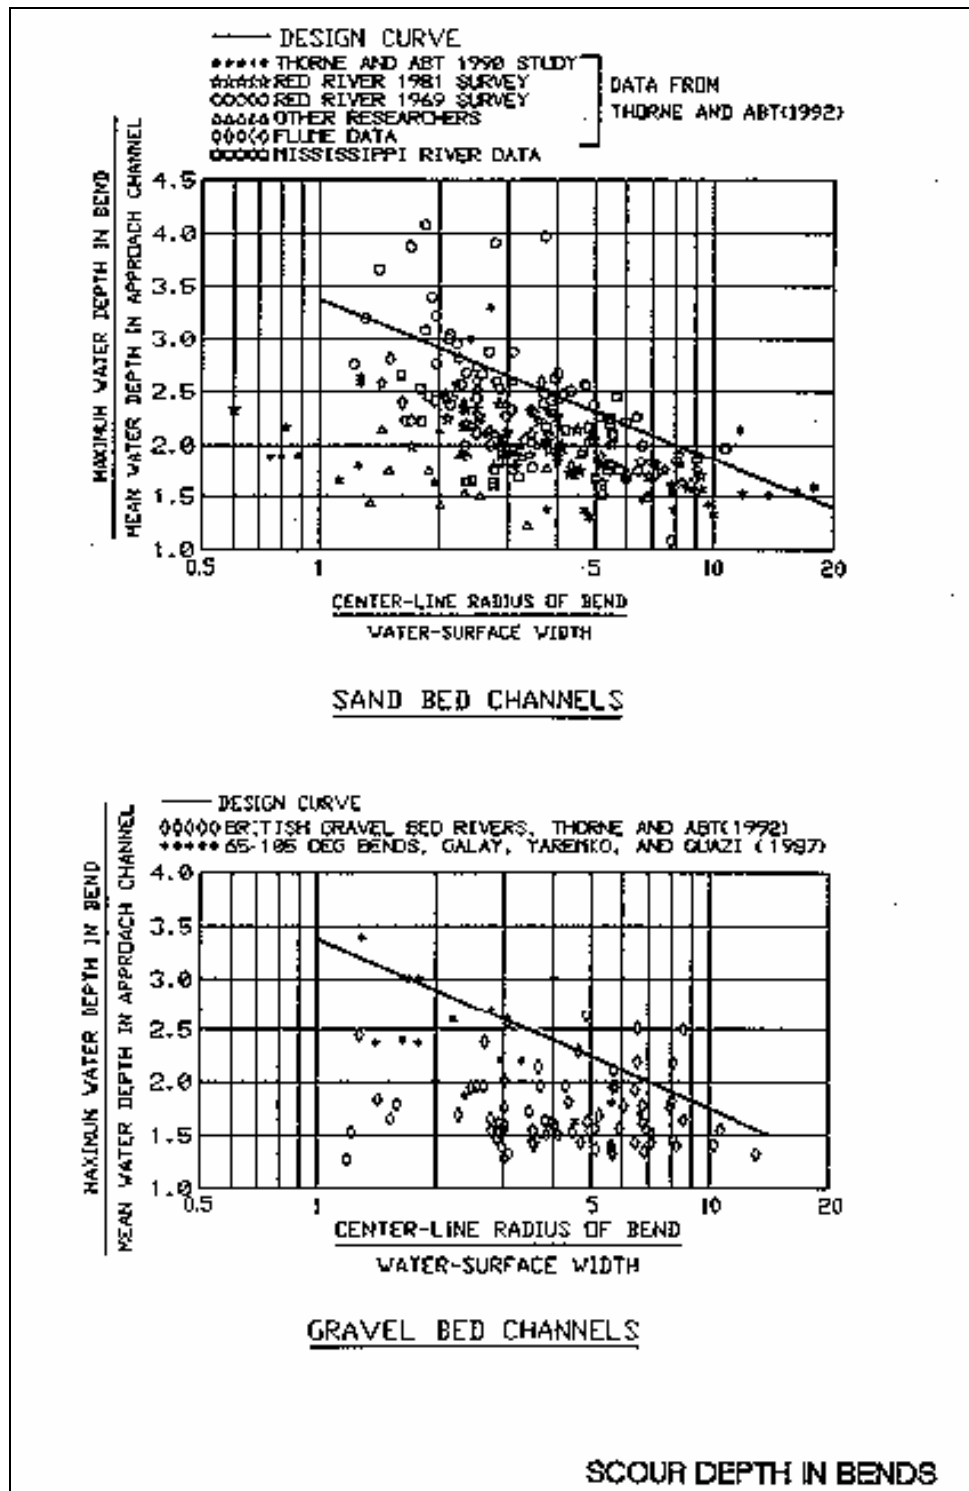
Figure 20. Plate B-42 from EM1601.

The COE manual EM1601 (COE, 1994) recommends using the following equation:
